Monthly Oversight Report 56
44728 AES [46526 RAC]
ACS NPL Site
Griffith, Indiana
August 6, 2005 – September 2, 2005

Subject: Monthly Oversight Summary Report
No. 56 for August 2005

Monthly Oversight Summary Report No. 56
ACS Superfund Site
TO 057, 44728.238 AES [WA57, 46526.238 RAC]

Reporting Period: Month of August (August 6, 2005 – September 2, 2005)

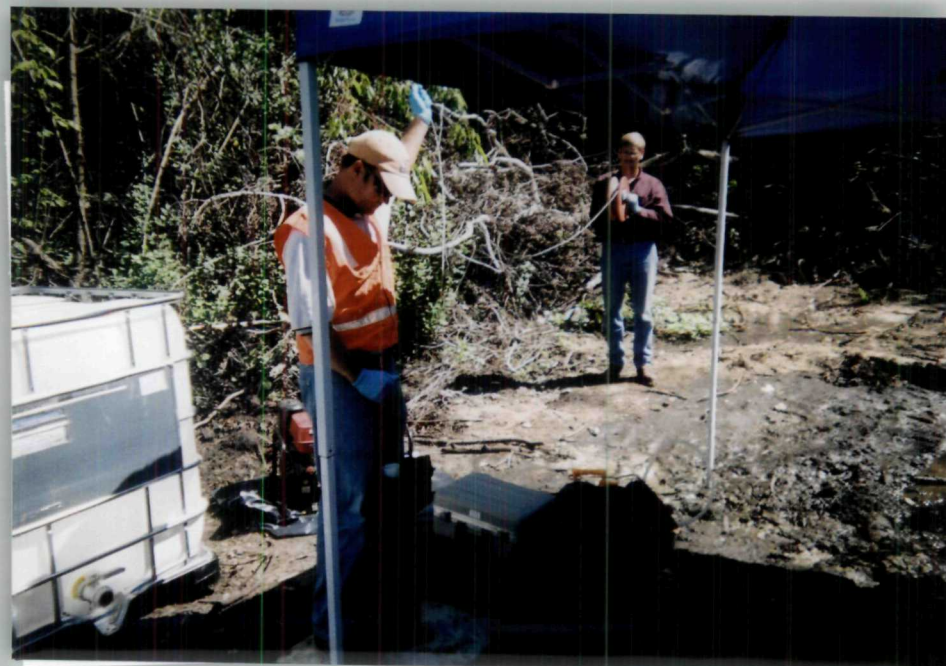
Site: American Chemical Service, Inc.
 Proj. #: 44728 AES [46526 RAC]
 Roll: 78 Photo #1
 Date: 08-23-05 Time: 1055
 Photographer: Larry Campbell
 Description: Photo facing east showing MWH starting to
 surge LA11 using surge block—didn't work,
 so completed development using bailer.

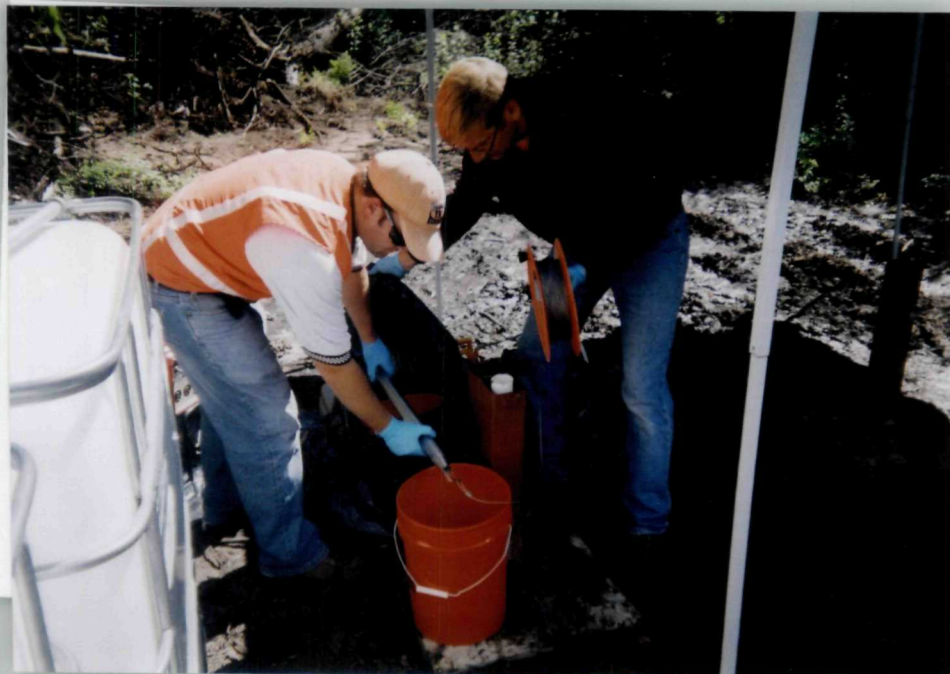
Site: American Chemical Service, Inc.
 Proj. #: 44728 AES [46526 RAC]
 Roll: 78 Photo #2
 Date: 08-23-05 Time: 1140
 Photographer: Larry Campbell
 Description: Photo facing east showing MWH pouring
 water from bailer at LA11.

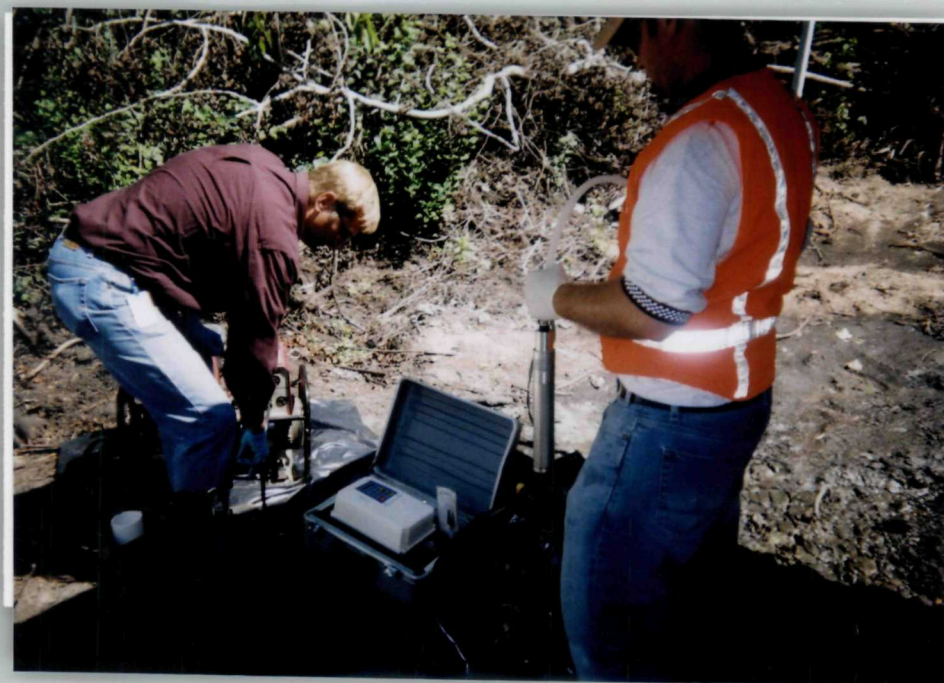
Site: American Chemical Service, Inc.
 Proj. #: 44728 AES [46526 RAC]
 Roll: 78 Photo #3
 Date: 08-23-05 Time: 1145
 Photographer: Larry Campbell
 Description: Photo facing northwest showing MWH
 preparing to lower peristaltic pump into well
 LA11.

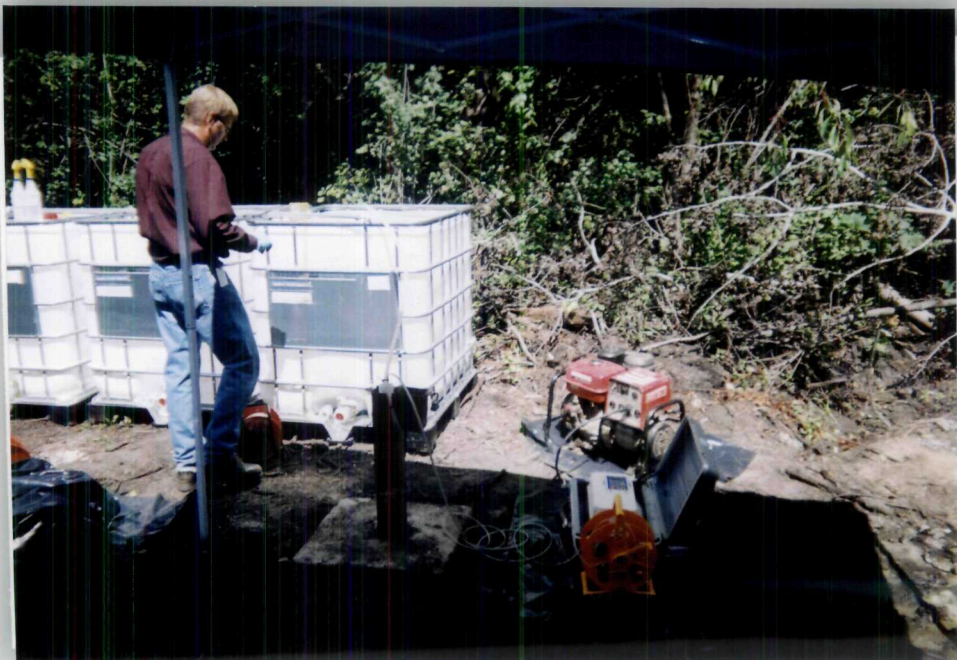
Site: American Chemical Service, Inc.
 Proj. #: 44728 AES [46526 RAC]
 Roll: 78 Photo #4
 Date: 08-23-05 Time: 1202
 Photographer: Larry Campbell
 Description: Photo facing north showing pump set-up
 to develop LA11. Plan to remove 1,750
 gallons + 10 well volumes (~200 gallons)
 from 88' deep well at 5 gpm.

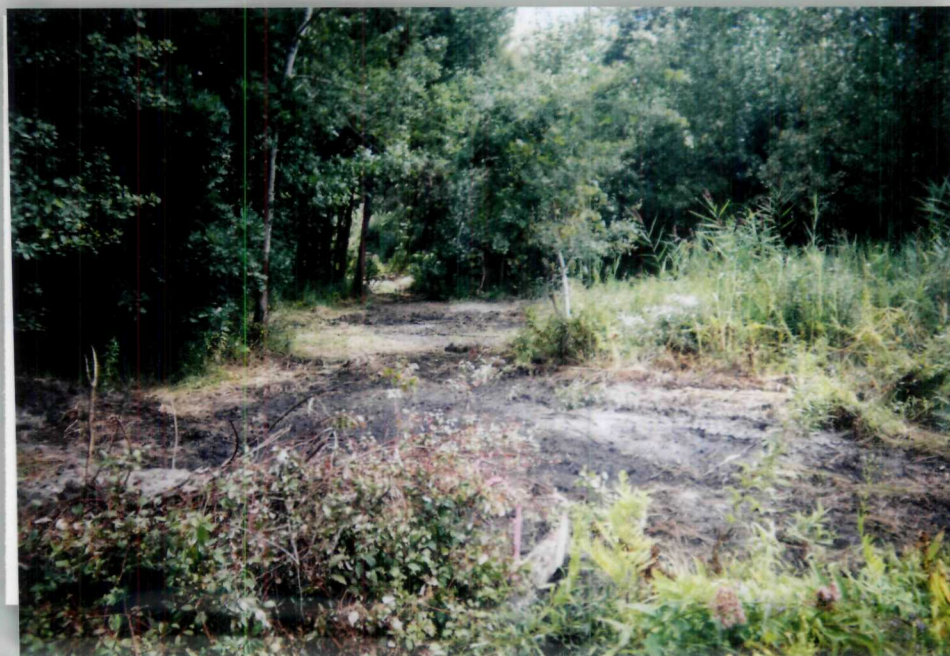
Site: American Chemical Service, Inc.
 Proj. #: 44728 AES [46526 RAC]
 Roll: 78 Photo #5
 Date: 08-23-05 Time: 1215
 Photographer: Larry Campbell
 Description: Photo facing northeast along line of Phase 1
 LA investigation wells in middle of
 marshland, after they have been abandoned.

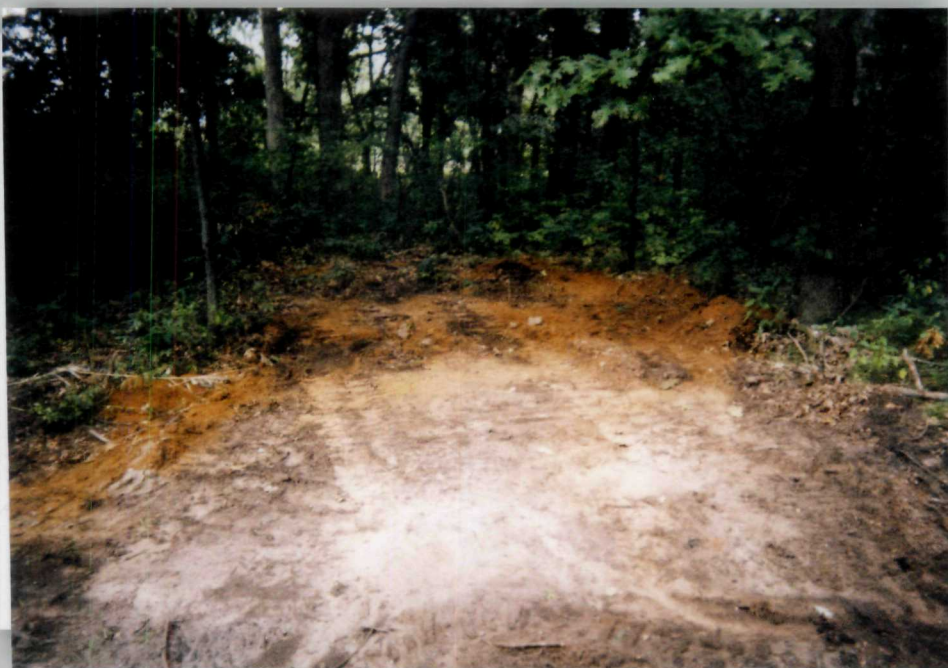
Site: American Chemical Service, Inc.
Proj. #: 44728 AES [46526 RAC]
Roll: 78 Photo #6
Date: 08-23-05 Time: 1216
Photographer: Larry Campbell

Description: Photo facing west showing location of abandoned Phase 1 LA well. Riser pipe cut off 2' bgs and covered with concrete and soil to surface.

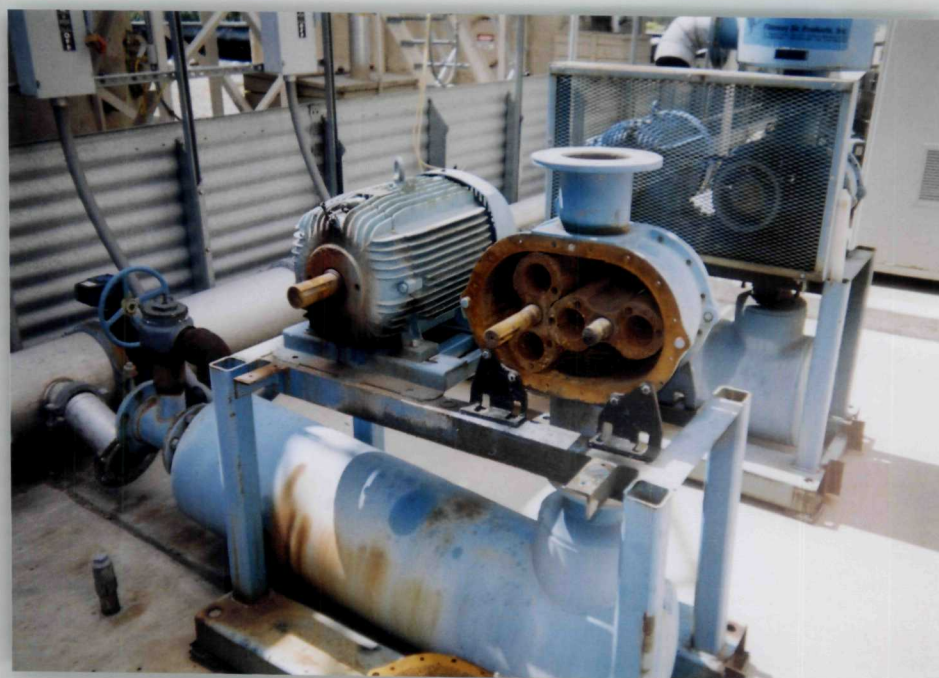
Site: American Chemical Service, Inc.
Proj. #: 44728 AES [46526 RAC]
Roll: 78 Photo #7
Date: 08-23-05 Time: 1400
Photographer: Larry Campbell

Description: Photo facing southwest showing blower ME104 that has been disassembled to check out reason it is non functioning.

H&S - NO issues this past month.
Subcontractor had tailgate mtf's
daily. Blower portion of ME104
replaced using mechanical lift -
no problems
